DOT/FAA/RD-94/22

①
**Composite Helicopter
Accident Profiles -
Deficient Crew/Aircraft
Performance**

Final Report

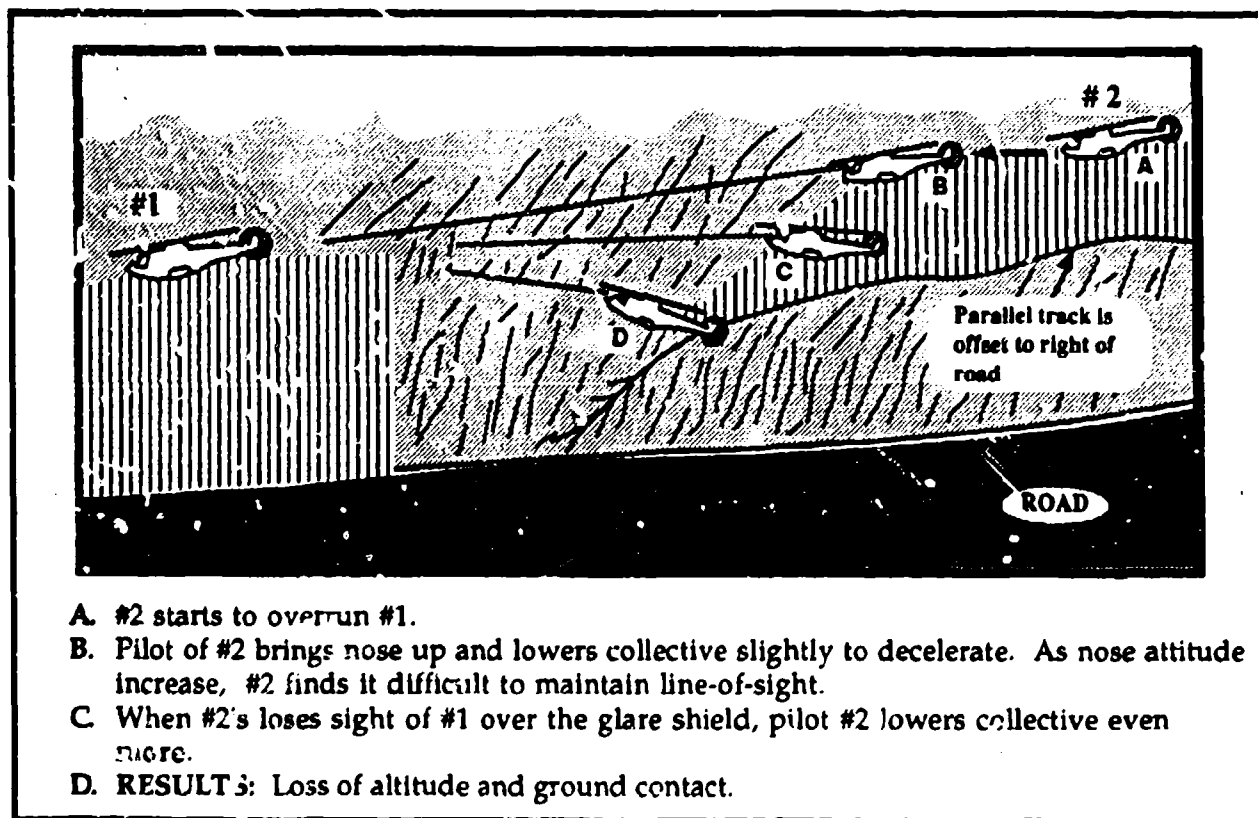
FIGURE 10-3. GROUND CONTACT DURING ATTEMPT TO MAINTAIN SAFE DISTANCE

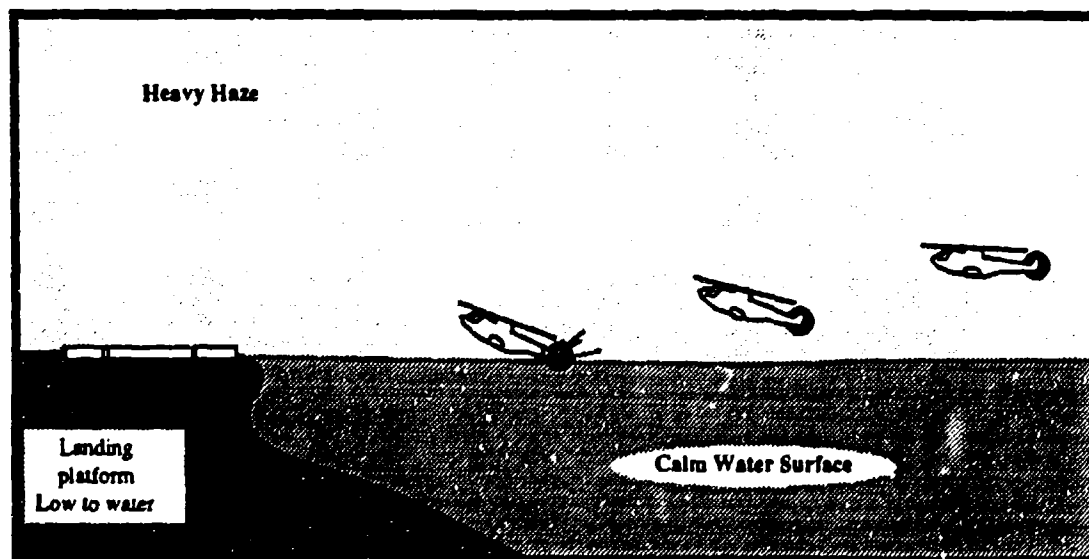
FIGURE 10-4. WATER CONTACT DURING ATTEMPTING TO DECELERATE AND RETAIN VISUAL CONTACT WITH LANDING SITE

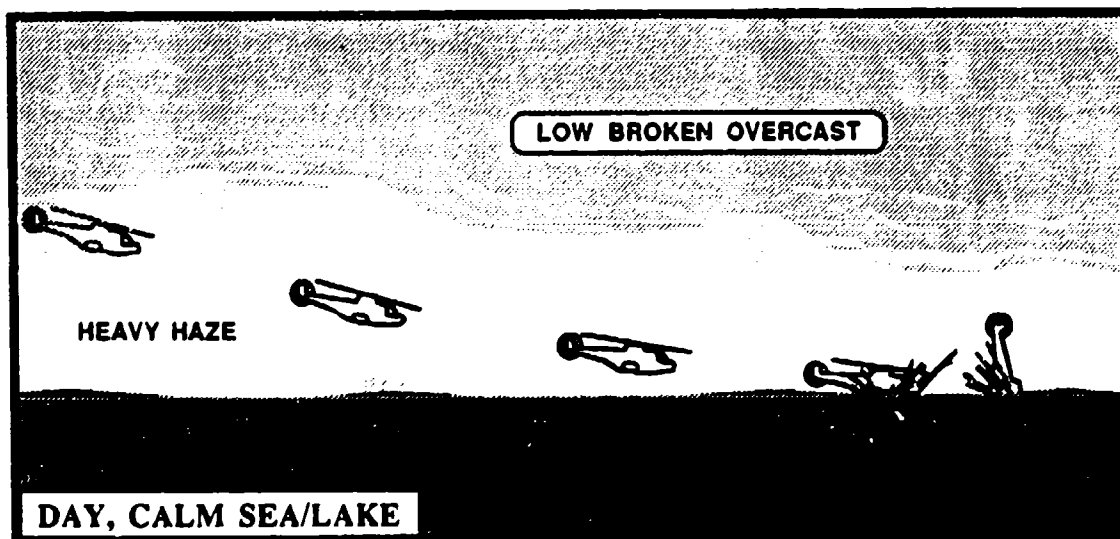
FIGURE 10-5. POOR ALTITUDE CONTROL DURING OPERATIONS OVER SLICK WATER SURFACE, UNDER OVERCAST

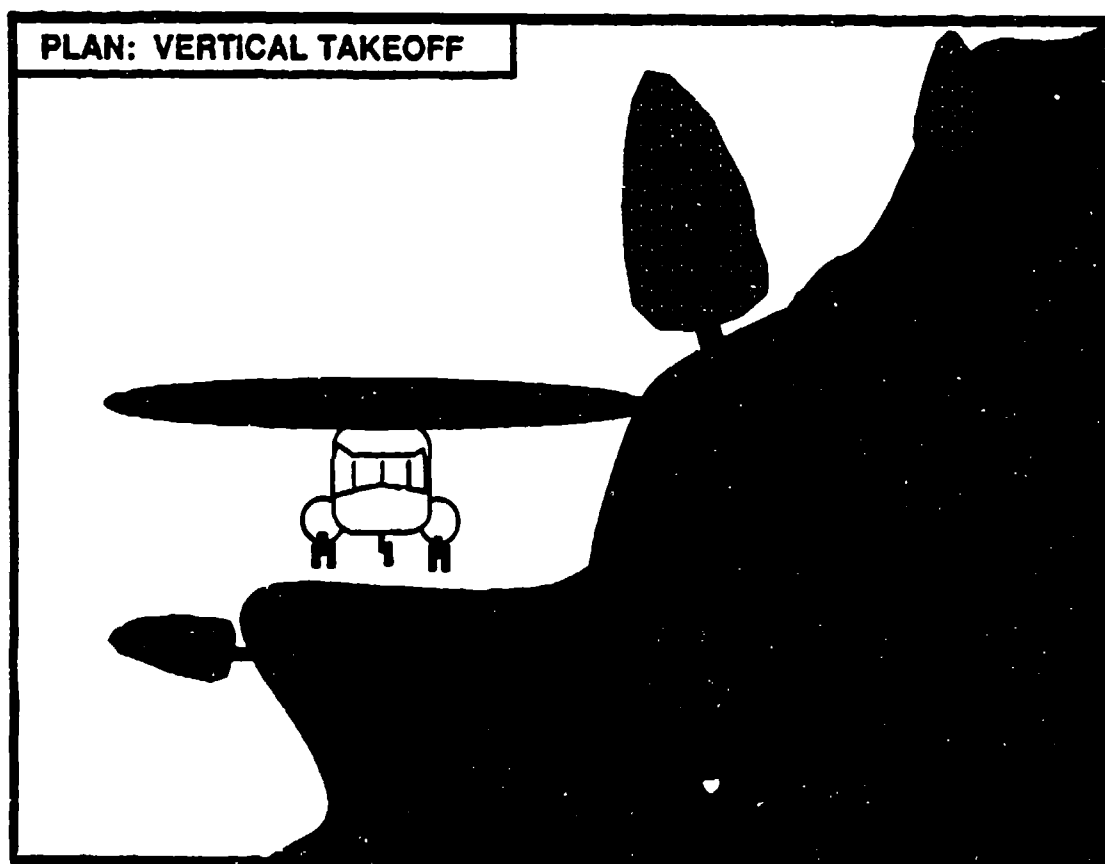
FIGURE 11-1. HIGH ALTITUDE TAKEOFF

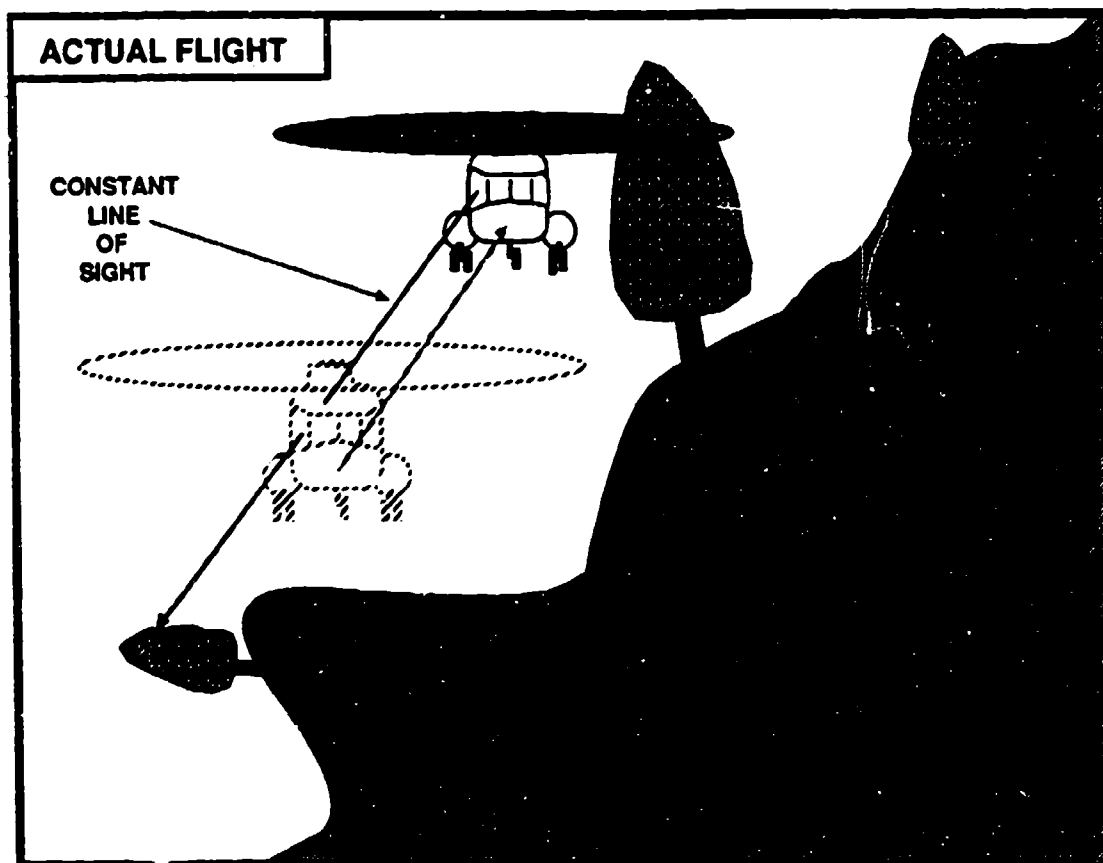
FIGURE 11-2. HIGH ALTITUDE TAKEOFF INTO OBSTRUCTION

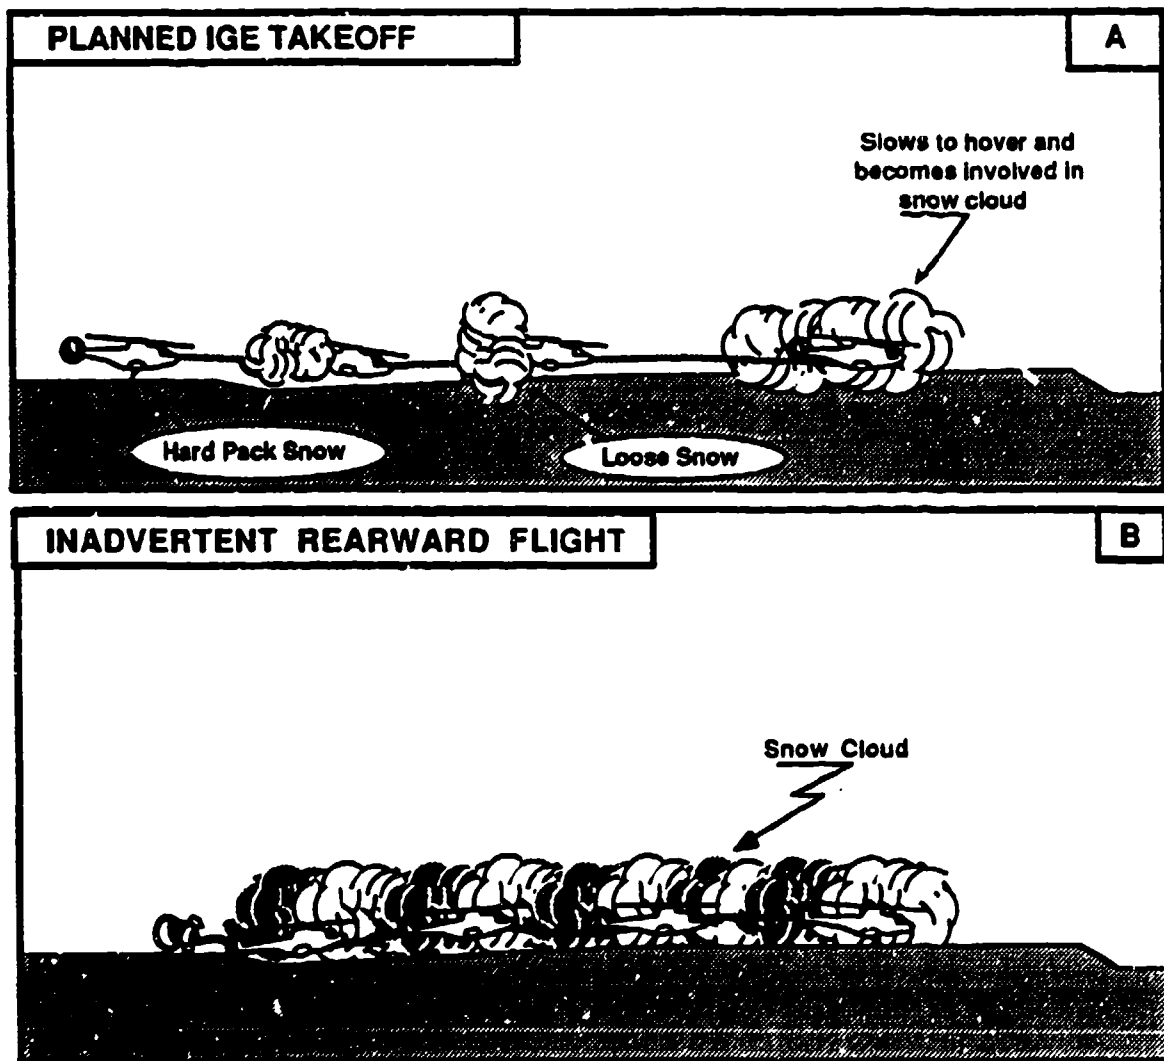
FIGURE 11-3. ATTEMPTED HIGH ALTITUDE TAKEOFF IN LOOSE SNOW

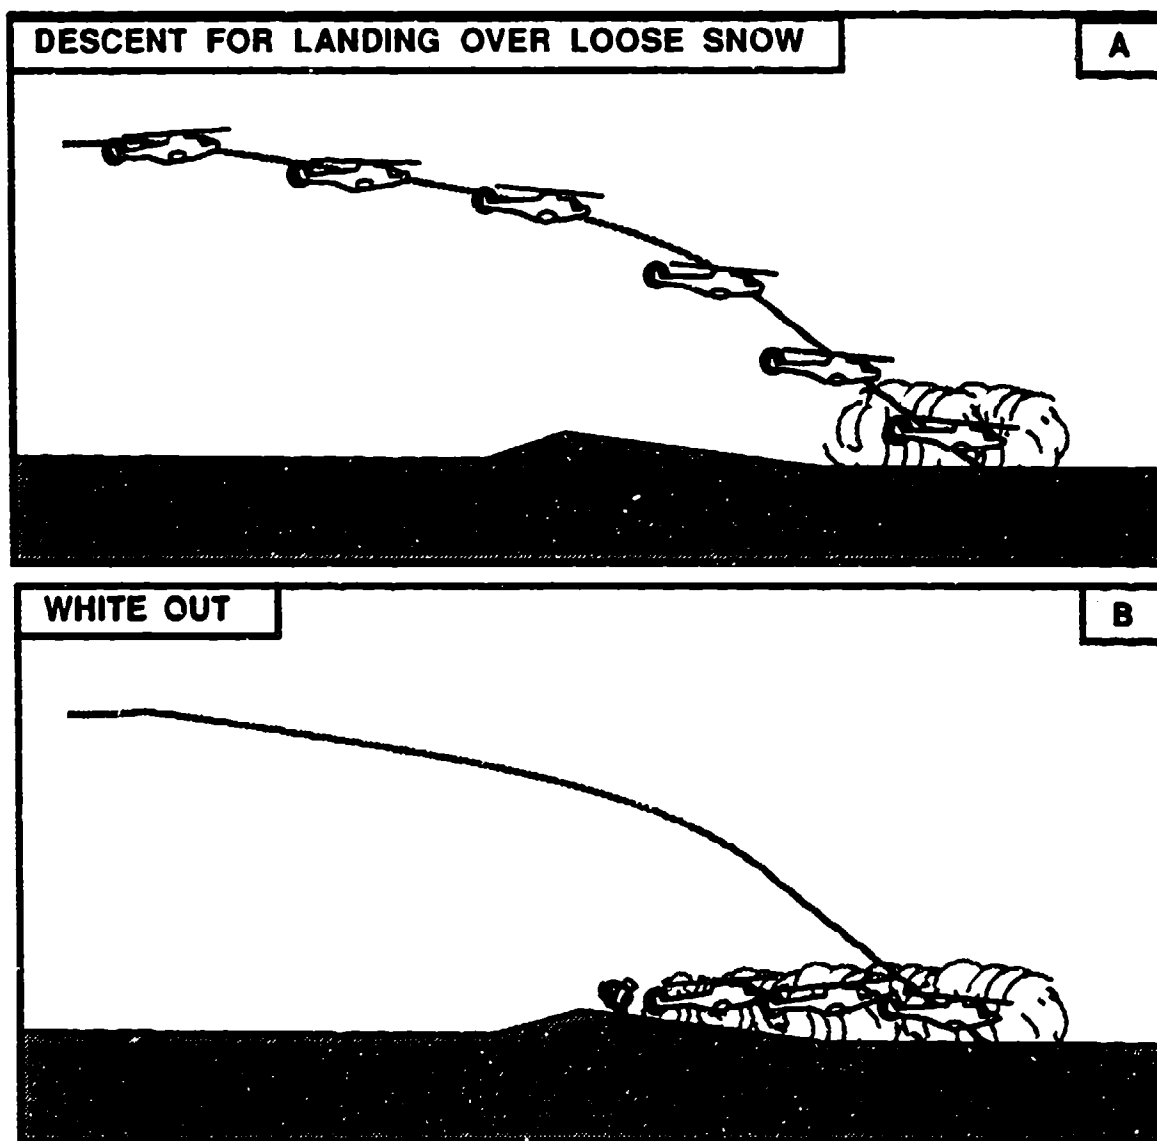
FIGURE 11-4. ATTEMPTED HIGH ALTITUDE LANDING IN LOOSE SNOW

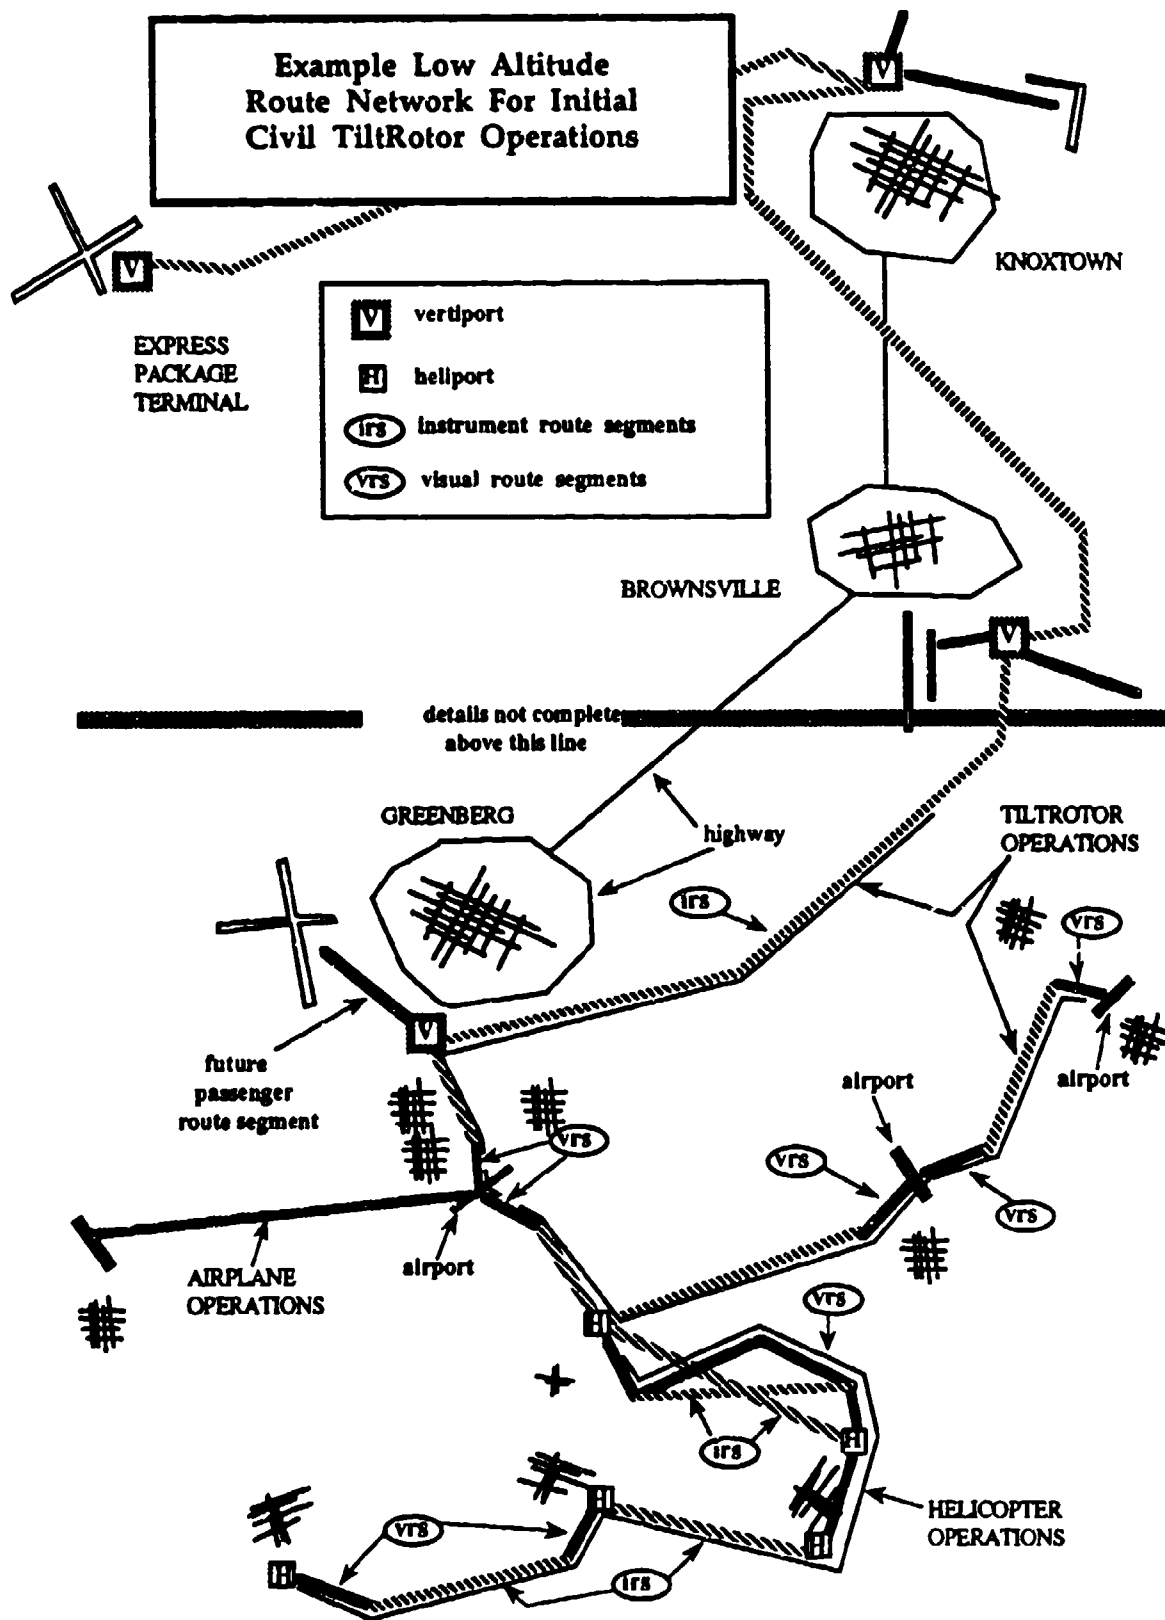
FIGURE 1. LOW ALTITUDE AIRWAYS FOR ROTORCRAFT

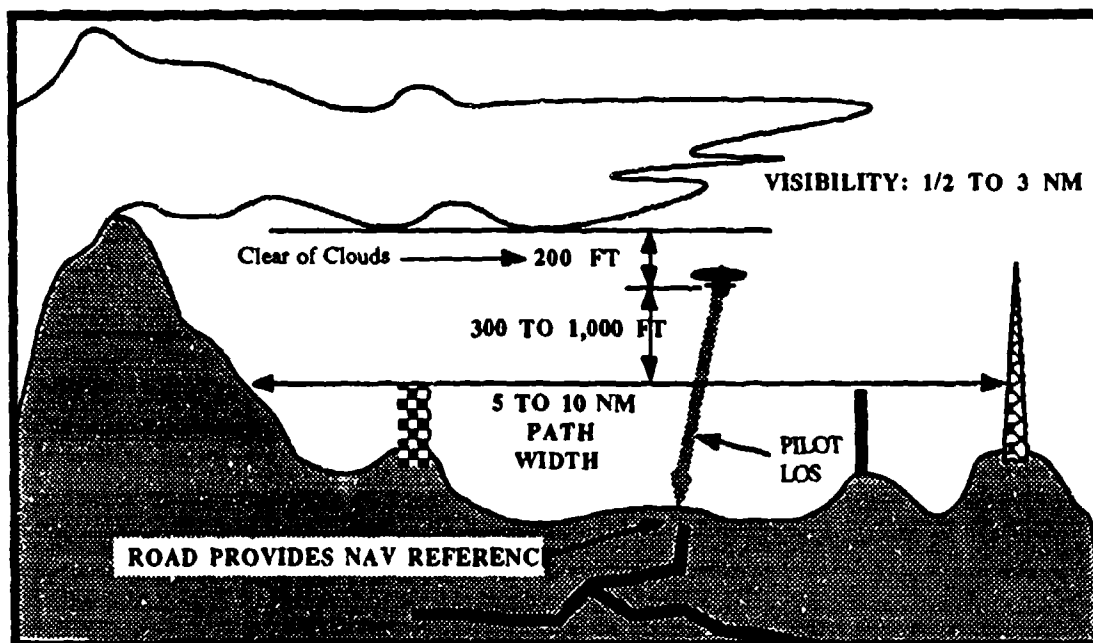
FIGURE 2. PLANNING EN ROUTE DVC FLIGHT
(Adapted from reference 7)

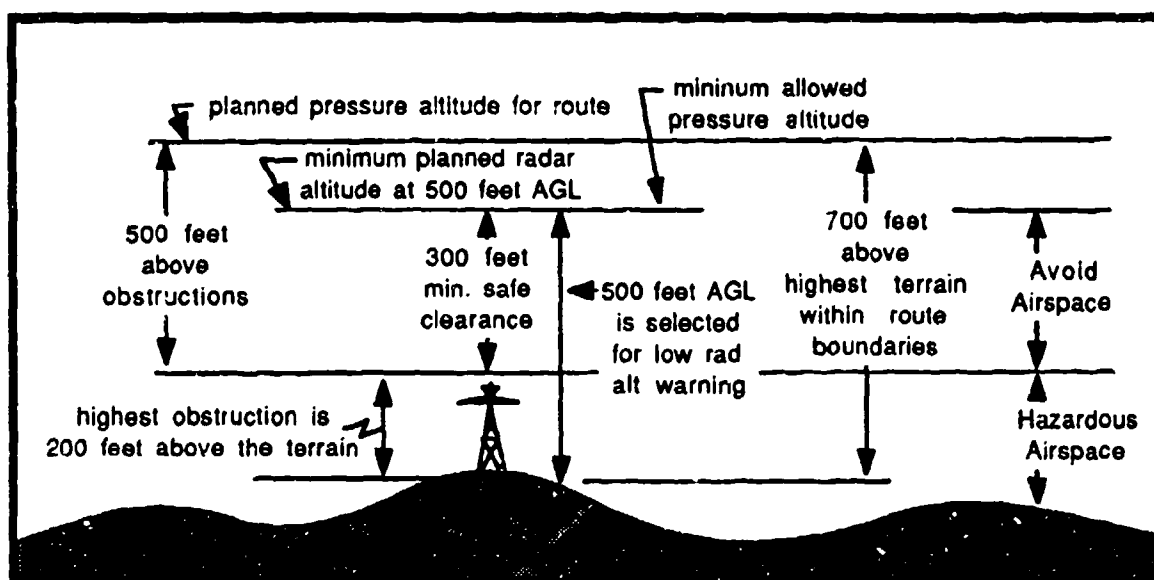
FIGURE 3. ESTABLISHING A PRESSURE ALTITUDE AND RADAR WARNING ALTITUDE FOR EN ROUTE OPERATIONS (Adapted from reference 8)

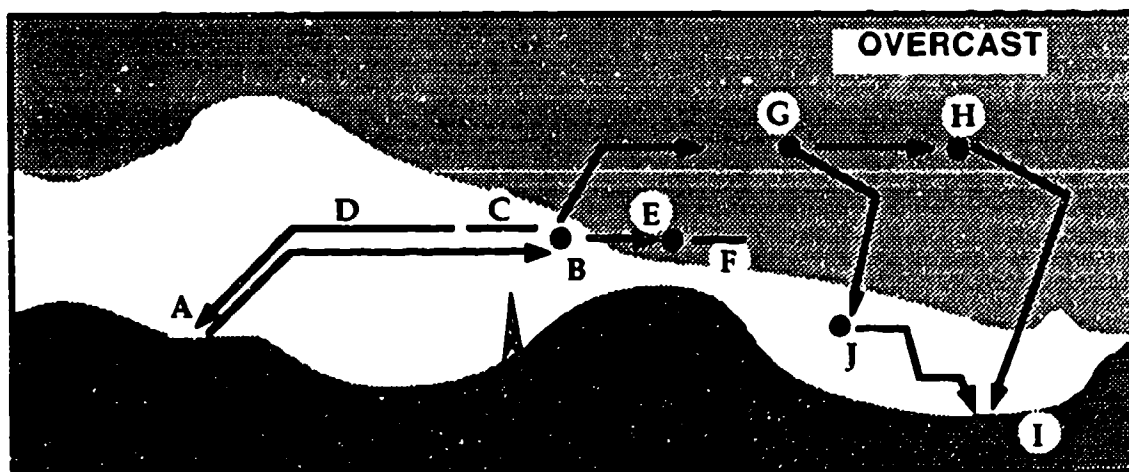
FIGURE 4. HELICOPTER FLIGHT PROFILE ALTERNATIVES

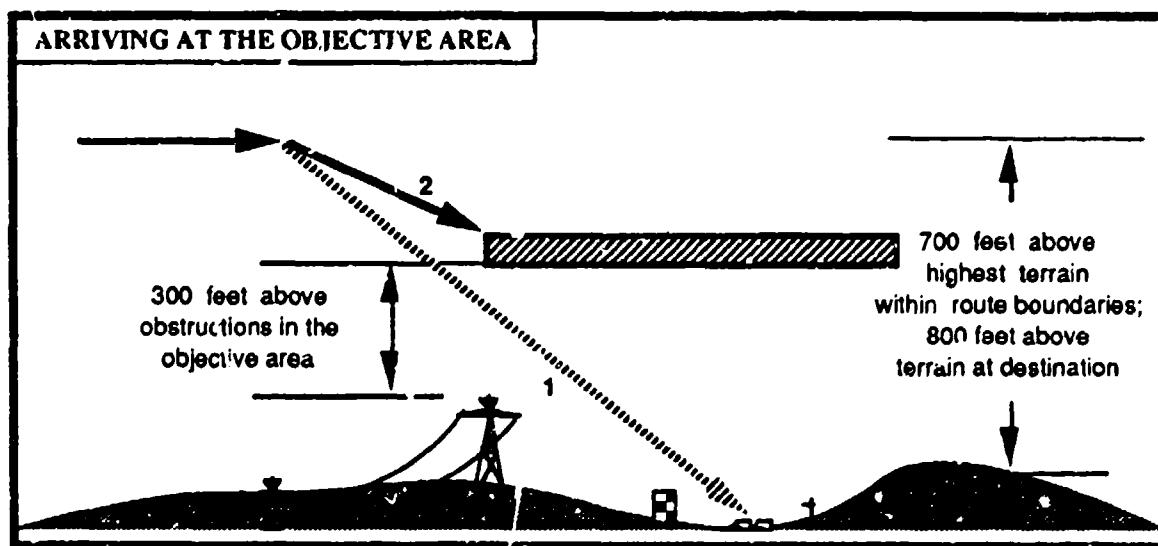
FIGURE 5. ARRIVING AT THE OBJECTIVE AREA
(Adapted from reference 8)

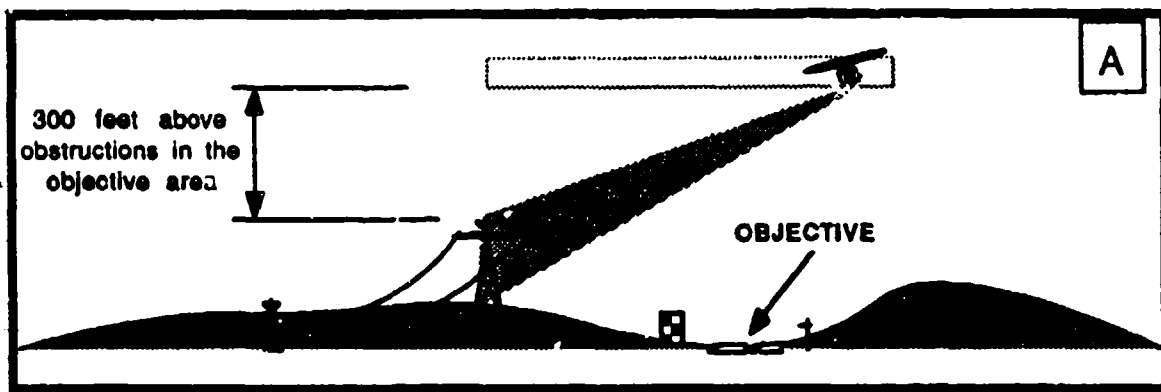
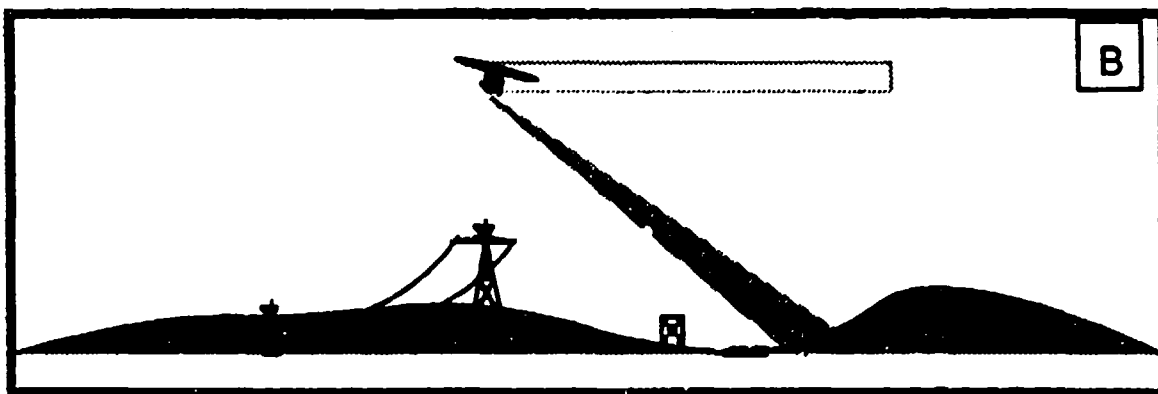
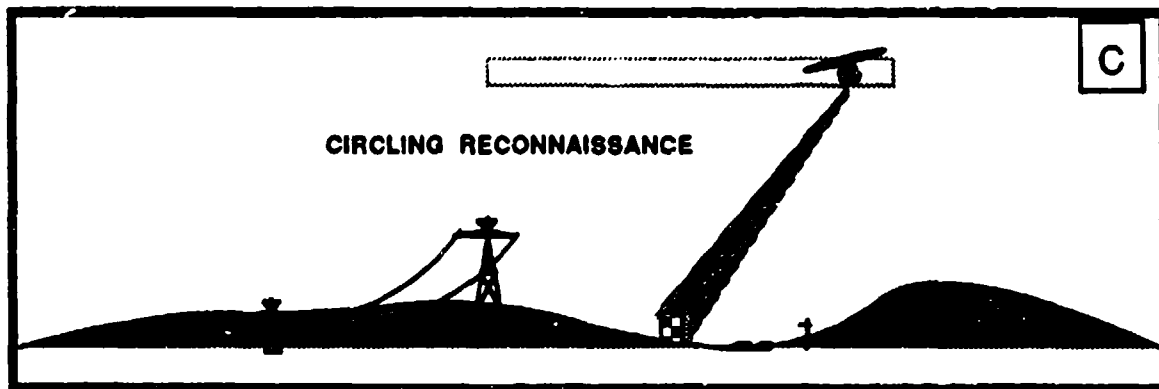
FIGURE 6. CONDUCTING A RECONNAISSANCE OF AN OBJECTIVE AREA
(Adapted from reference 8)

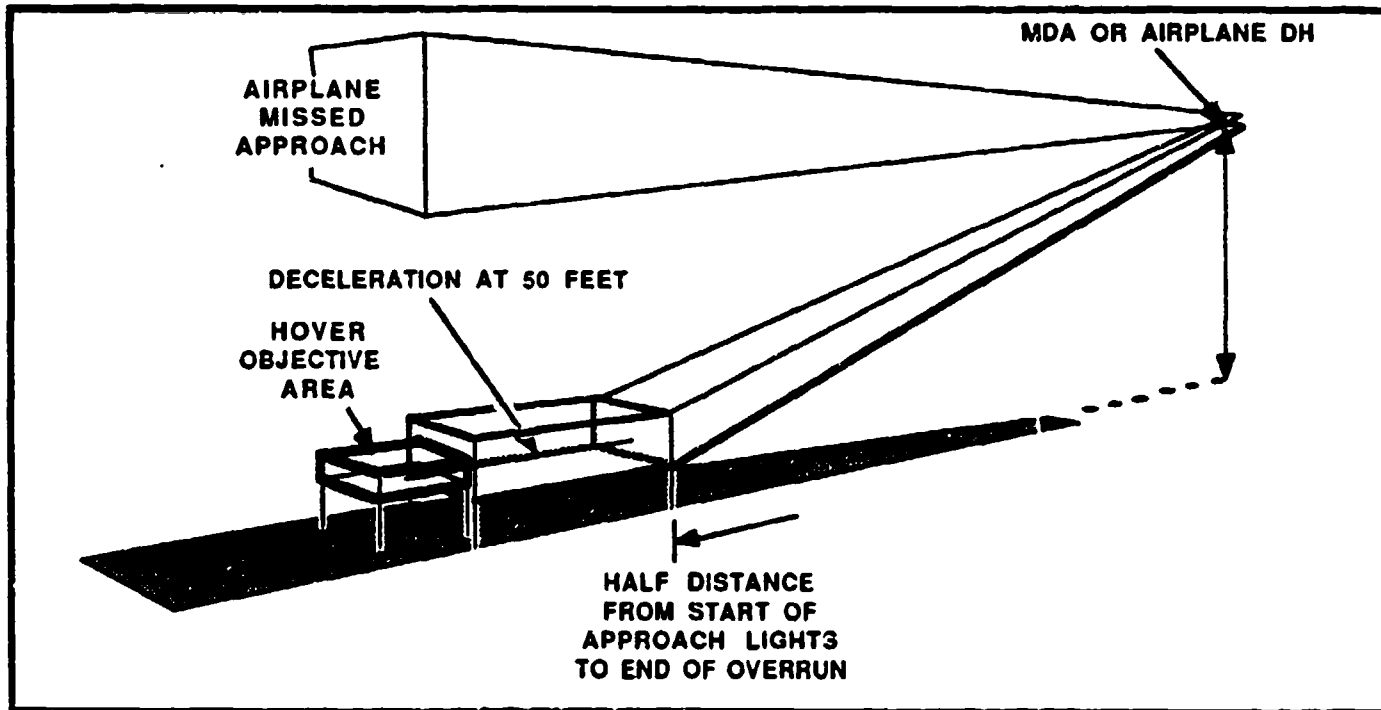
FIGURE 7. APPROACH TO A REGIONAL AIRPORT
(Adapted from reference 4)

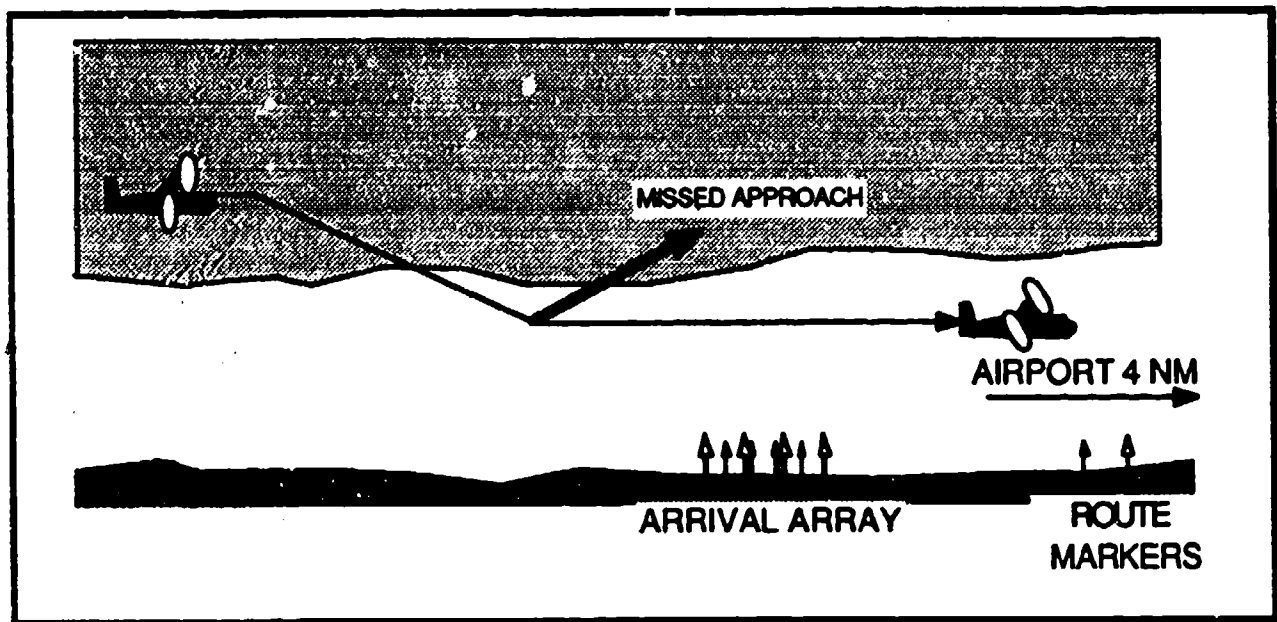
FIGURE 8. POINT-IN-SPACE APPROACH TO A VISUAL AIRWAY LEADING TO AN AIRPORT, HELIPORT OR VERTIPOINT

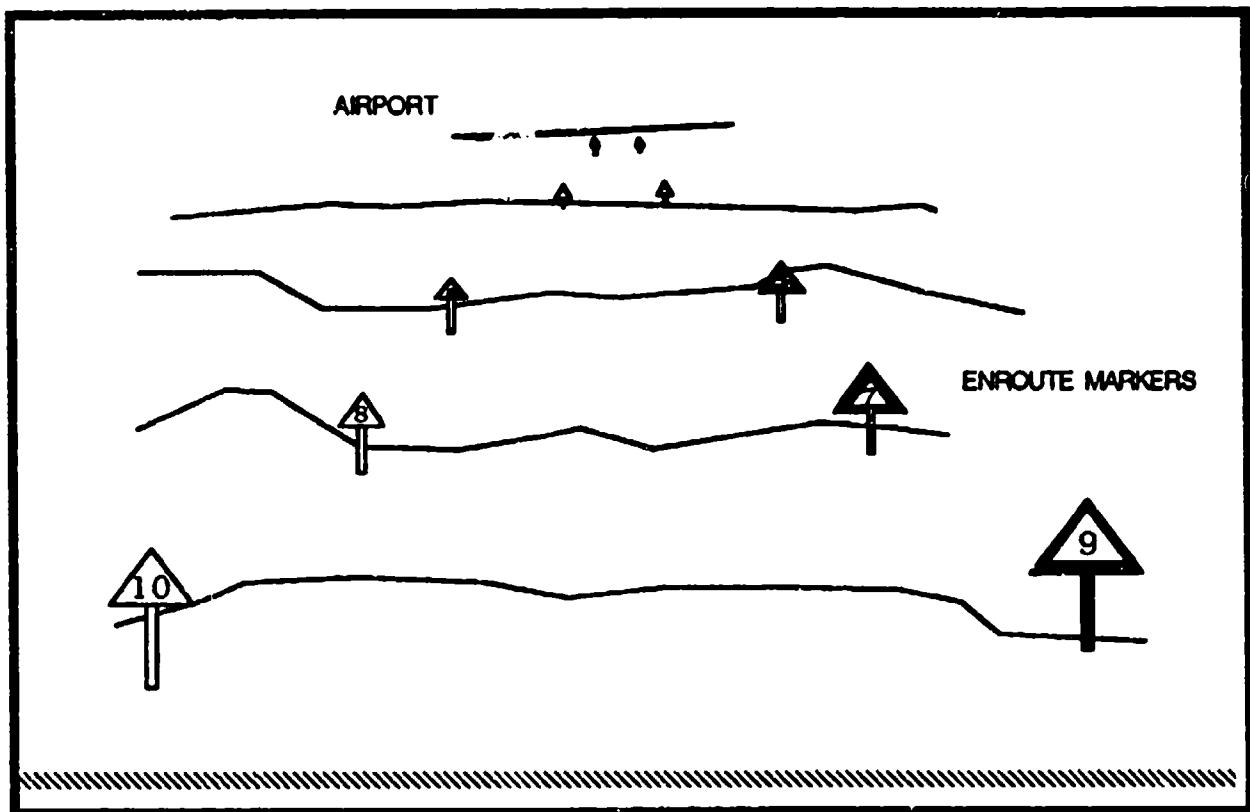
FIGURE 9. EXTENDED VISUAL AIRWAY LEADING TO AN AIRPORT

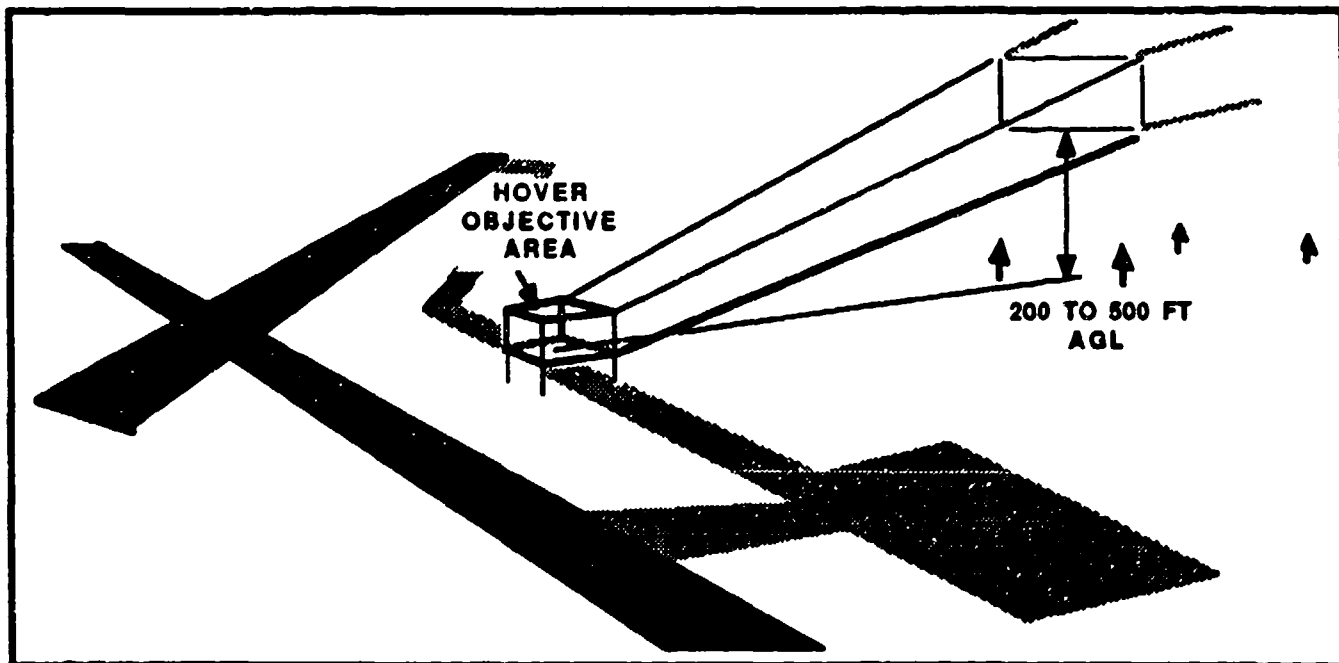
FIGURE 10. PROPOSED ARRIVAL AIRSPACE FOR VISUAL APPROACH TO AN AIRPORT OPERATING IFR

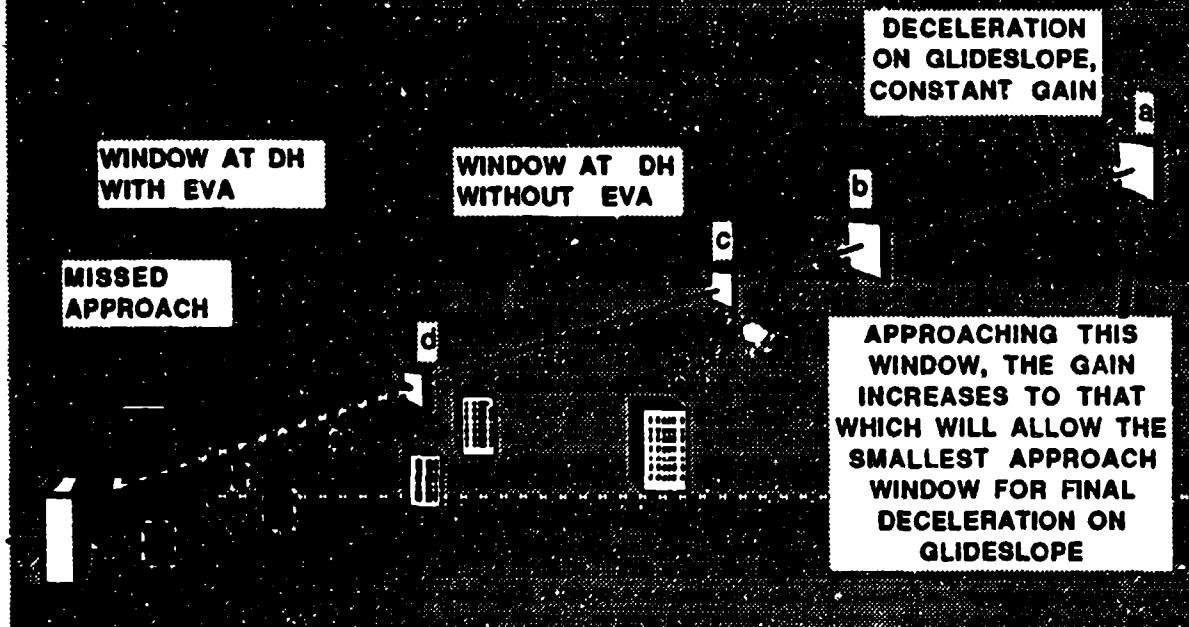
FIGURE 11: DESIGN CONDITIONS WHEN CONSIDERING FLIGHT CONTROL METHODS, ELECTRONIC VISION AIDS (EVA), AND WINDOWS FOR A FUTURE HELICOPTER INSTRUMENT APPROACH TO A CITY/TOWN HELIPORT
(Adapted from reference 11).
